4 COMMON SOURCES OF WINTER ROOF LEAKS

How to Figure Out if the Leak from Ice Dams or from Something Else?

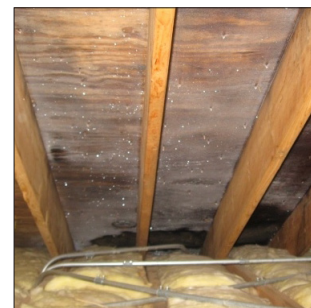
If possible, it can be tremendously helpful to peak into the attic. A healthy attic with good ventilation (Ice Dam Company Case #17) should not present moisture or frost on the framing members or roof decking. The photo, right, shows a poorly insulated, ventilated and air-sealed attic. Notice the frost on the underside of the roof decking? This is not good. Attic frost can cause tremendous damage and is most likely to accumulate when temps are quite low (below 10°F). Warm, moist air meets the ice-cold roof deck and freezes into frost. This cycle continues until as much as 1/8" to 1/2" of frost has built up. When outdoor temps rise above freezing, all of that frost melts and has nowhere else to go by the interior of the house. This type of 'leak' is tricky because it is actually not a leak. We have seen clients spend thousands of dollars trying to resolve a roof leak that was in fact nothing more than attic condensation. Future Ice Dam Company Case Studies will discuss how we fix this issue.
